**LAKE CHILLISQUAQUE**

NDS ID NO. PA-815

PHASE I INSPECTION REPORT  
NATIONAL DAM INSPECTION PROGRAM

NAME OF DAM: Lake Chillisquaque Dam  
STATE LOCATED: Pennsylvania  
COUNTY LOCATED: Montour  
STREAM: Middle Branch of Chillisquaque Creek  
DATE OF INSPECTION: May 23, 1979

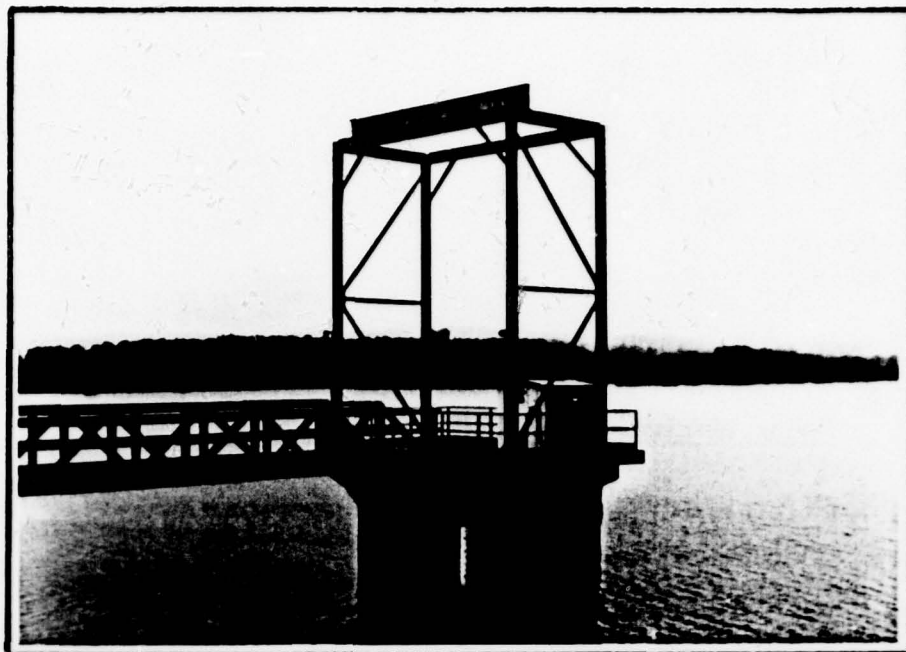
The condition of the two 36" drainlines was unobserved during the inspection. The concrete control tower appeared to be in good condition. The discharge end of the pipes and the valve house appeared to be in good condition. The valve house is kept locked at all times. Operation of the valves is controlled at the power plant, however, the valves can be operated manually in the valve house.

Close-up of control tower.

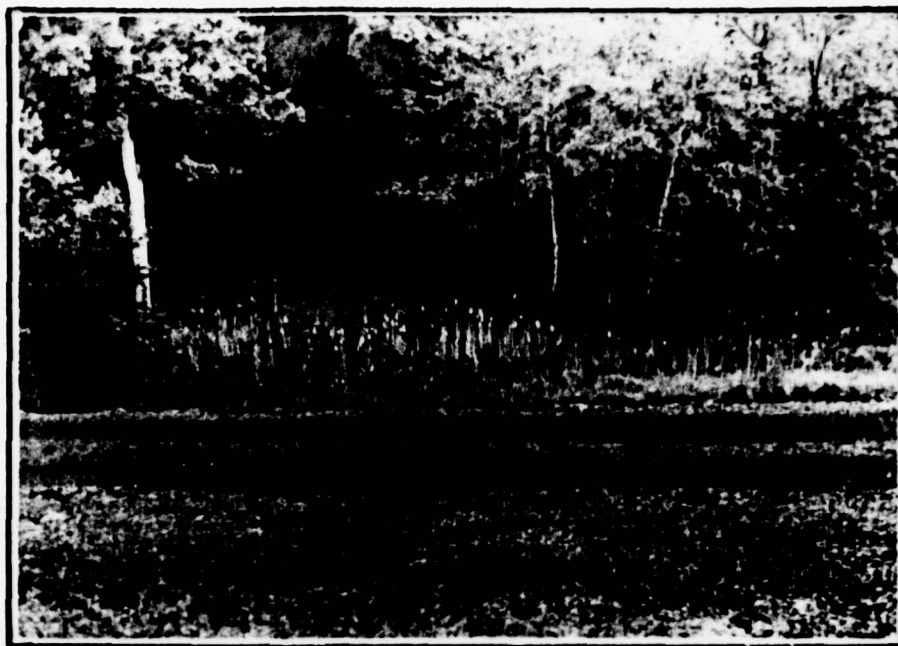
Note: Considerable precipitation occurred prior to and during a portion of the inspection possibly contributing to the wet areas noted at the toe and also possibly obscuring any small volume seeps or isolated wet areas. Dry weather inspections by the owner are encouraged.

a. Visual Observations. No signs of slumping, erosion or instability were noted during the inspection. The wet area at the toe of the dam should be watched for significant changes.

Wet area at downstream toe.

1. Continue to remove all trees from the embankment.
2. The wet areas at the toe of the embankment should be examined during the routine inspections. Drainage from these areas should be provided and flow monitored when it exists.
3. A formal inspection program should be instituted.
4. A warning system should be instituted to warn downstream residents of large spillway discharges or failure of the dam.
5. Valves should be operated and lubricated on a regularly scheduled basis.
